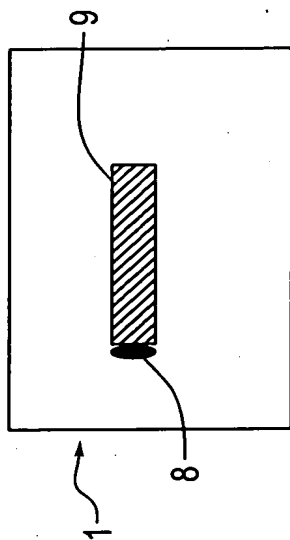
Fig. 1(a)

Rectangular disbondment with a holiday defect at one end

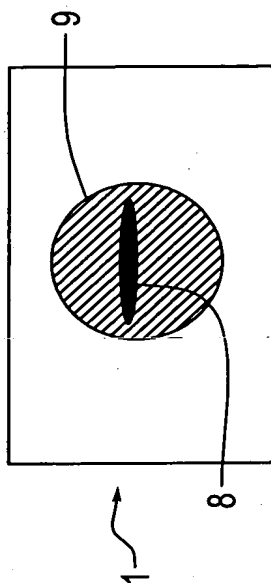
Fig. 1(b)

A circular disbondment with a small gap and a crack in the middle

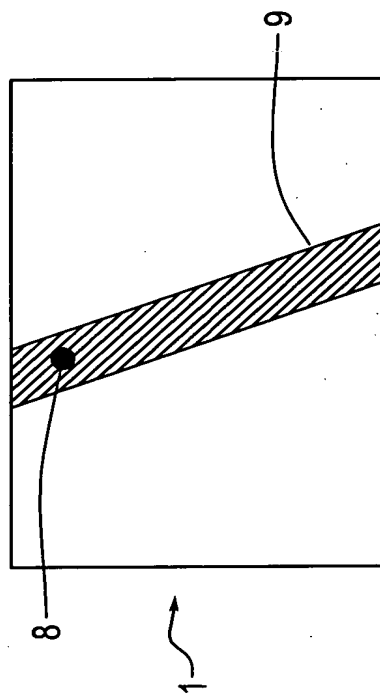
Fig. 1(c)

Disbondment along overlap of a spirally wound tape coating and a holiday at one section

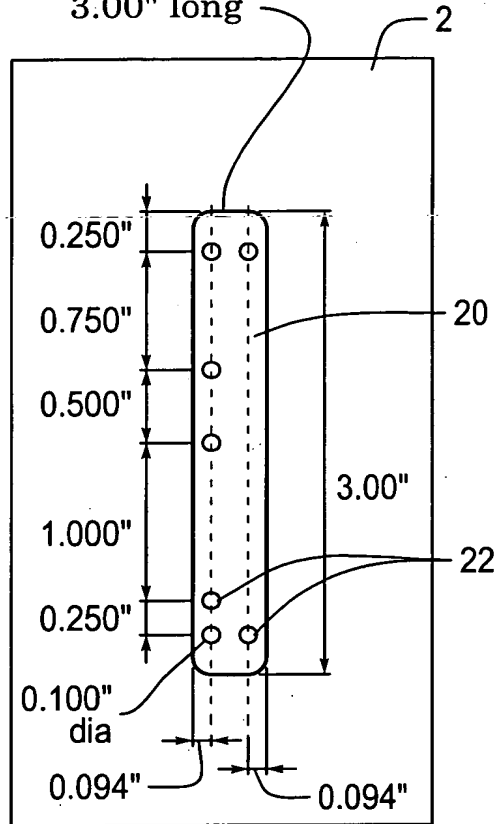
Fig. 4(a)

Tapered channel
 0.375" wide
 0.120" deep max
 0.040" deep min
 3.00" long

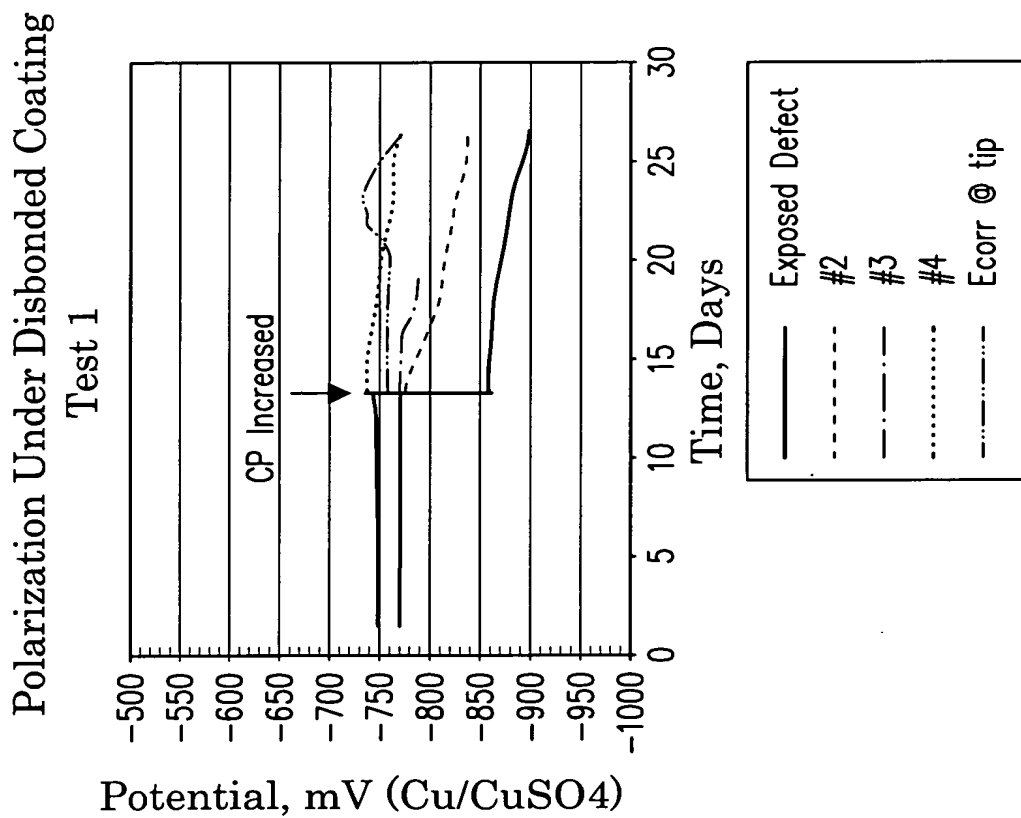
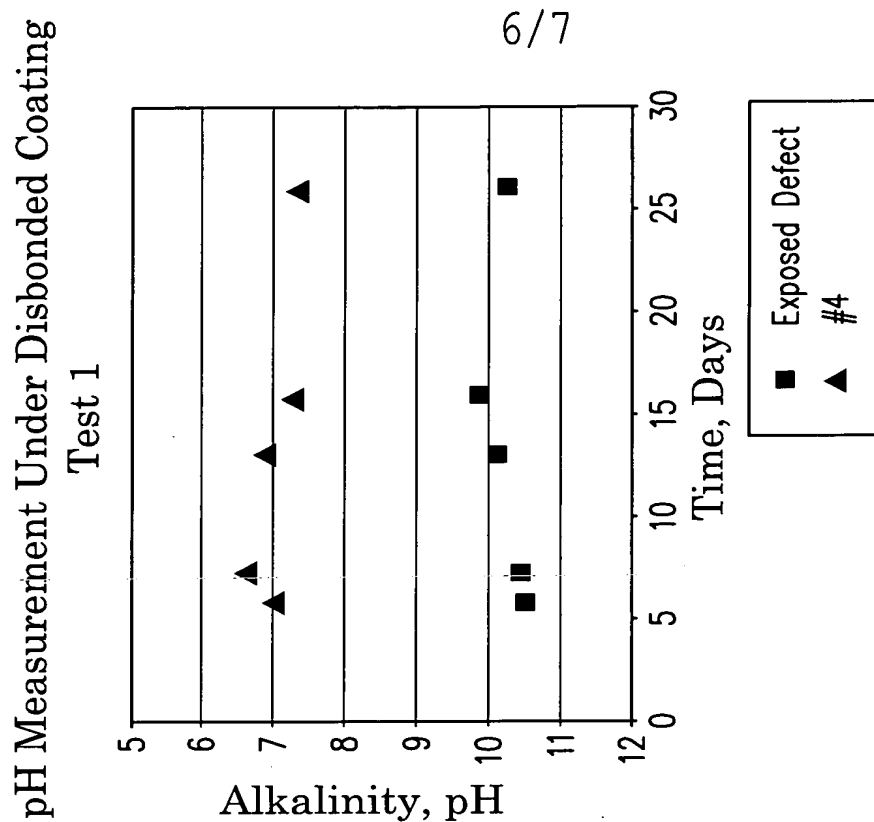
Fig. 6

Test 1 polarization and pH data collected under a coating disbondment and adjacent exposed defect.

Polarization Under Disbonded Coating

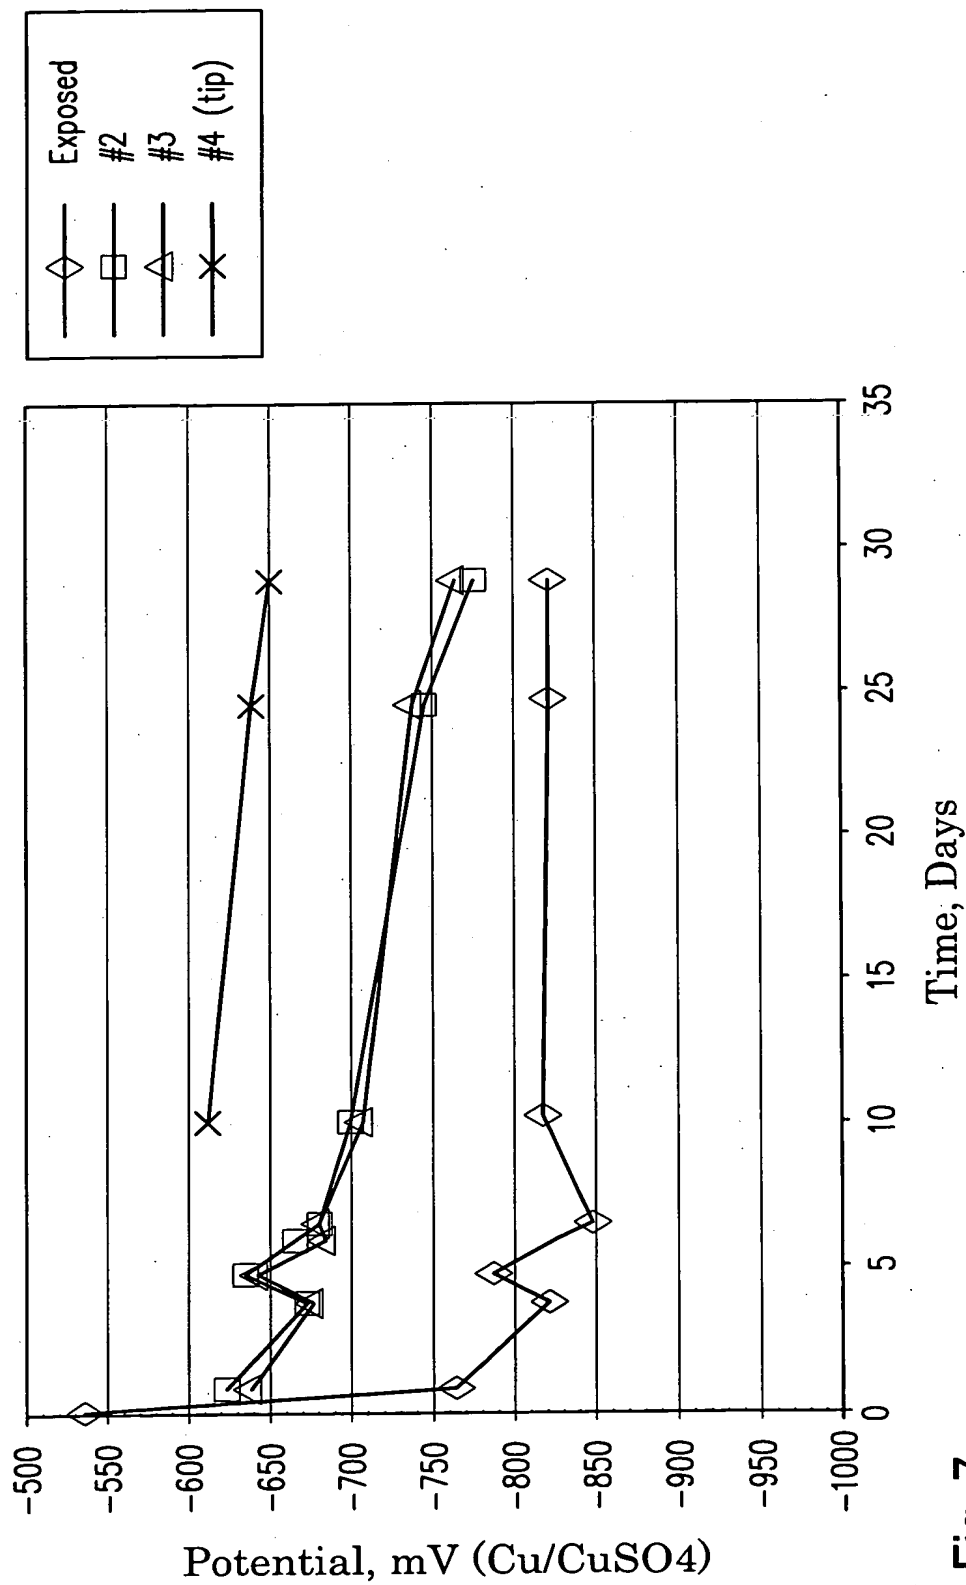
Fig. 7

Test 2 polarization data collected at an exposed defect and under an adjacent coating disbondment.
